Influence of Geological Structure on Dam Behavior and Case Studies

Arash Barjasteh

Complex engineering projects including large dams require extensive reconnaissance. The study of geological relationships is therefore of major importance, with emphasis on the characteristics of the geological structures. Accordingly, geologic structure affects dam site and reservoir behavior in three ways: (1) its impact on the geomechanical properties of rocks; (2) the importance of geologic structures in the identification and assessment of karst hydrogeology; and (3) its role in seismotectonic and seismic risk analysis of dam projects. Site geology and availability of various geologic data obtained from site investigation are key points in dam construction. Geological structure plays an important role in dam site geology and imposes major limitations on dam behavior during and after construction stages. This role has its own effect on major subjects such as: morphotectonics of rivers; geotechnical properties and engineering geology of dam sites; and hydrogeology of dam abutments and reservoir. The variability and complexity of geological structures regarding their tectonic situation result in

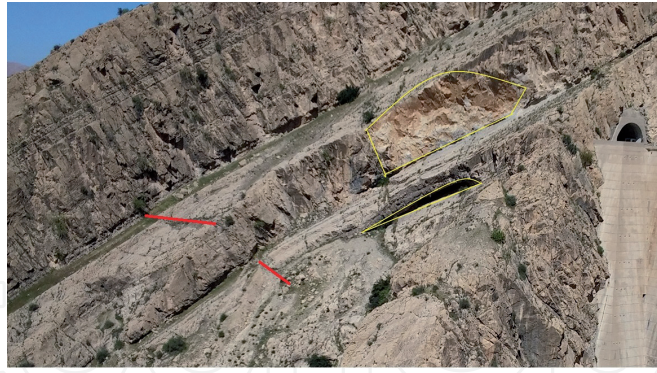
Figure 7. Rock sliding (in yellow) at right abutment of the dam.

Here, due to the downstream dip of bedding, which is unfavorable for a dam site, a natural potential for rock fall and slide on the dam abutments was predictable (**Figure 7**). This geological condition is of key importance since the southwestern (downstream side) limbs of the Zagros anticlines are usually very steeper than the northeastern limb due to the action of thrust faulting that affect the southwestern anticlinal limbs [30, 31]. New observations proved the subject and some rock slide and fall happened especially on the right abutment. There seems to be some flexuring along the bedding plane as well. The vertical tensional joints on the right abutment could amplify rock falling.
